Facility Condition Assessment

East Providence - East Providence High School

June 2017

2000 Pawtucket Avenue, East Providence, RI 02914

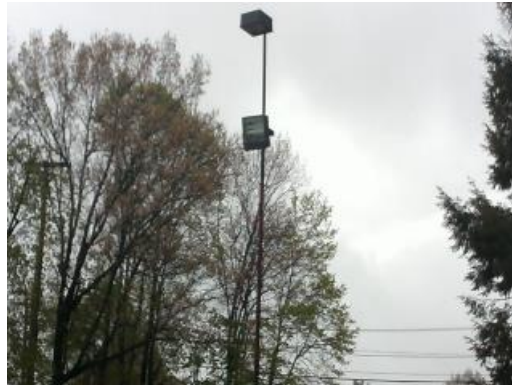
Aged Pole Lighting

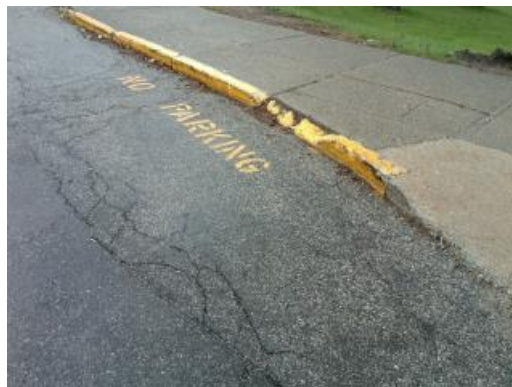
Alligatored Roadway Pavement

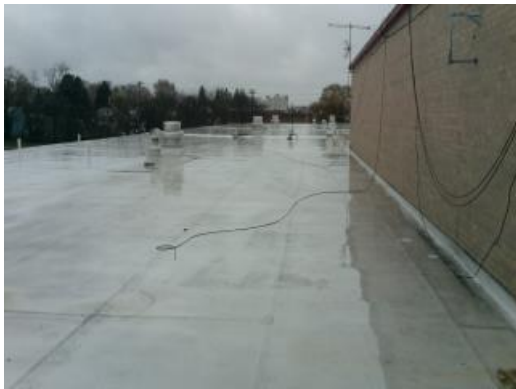
General Roof Condition

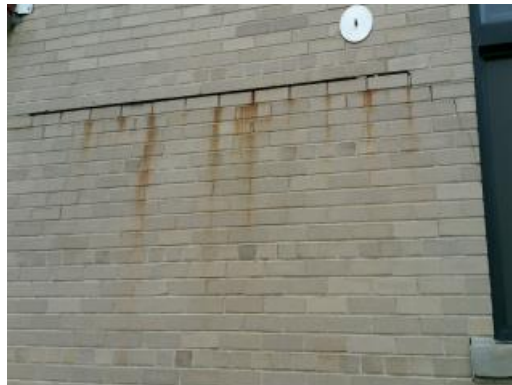
Cracked Exterior Brick

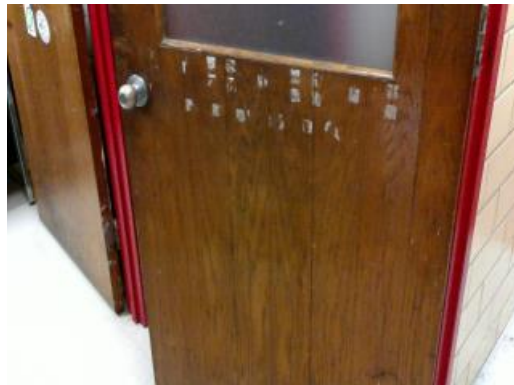
Aged Door And Hardware

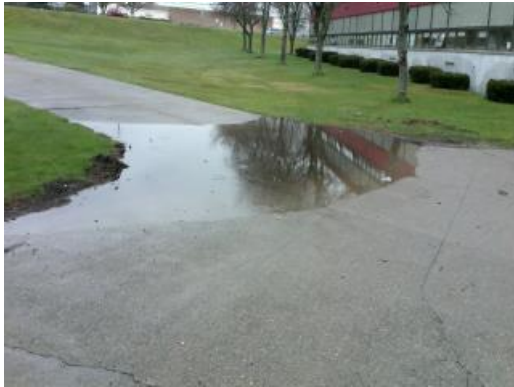
Front Entry Drainage

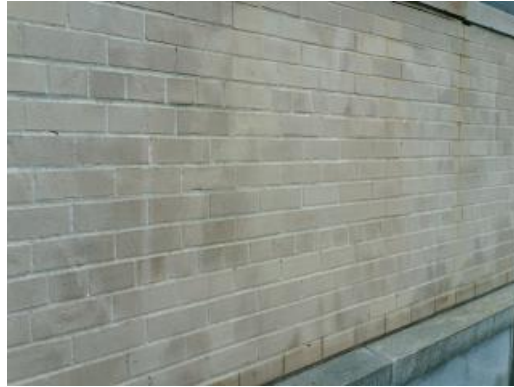
Repointing Needed

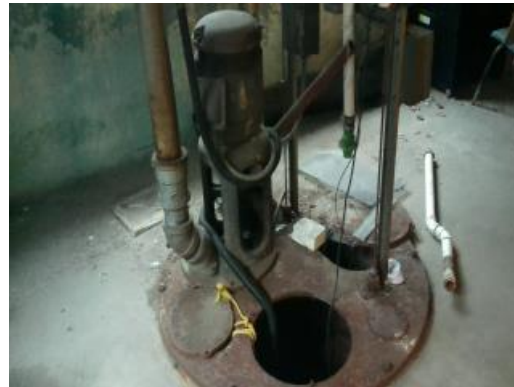
Aged Sump Pump

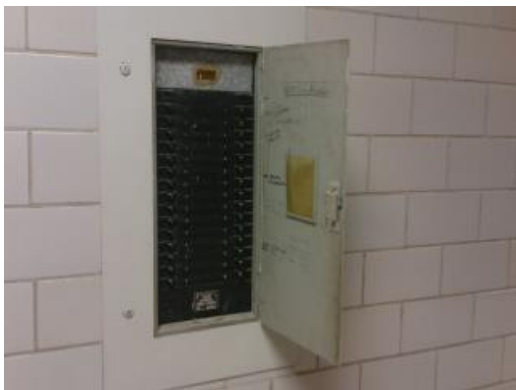
Aged Panelboard

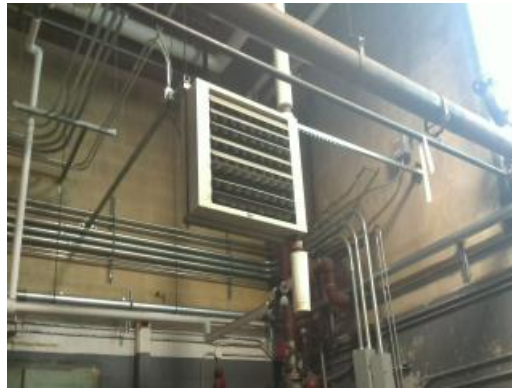
Aged Unit Heater

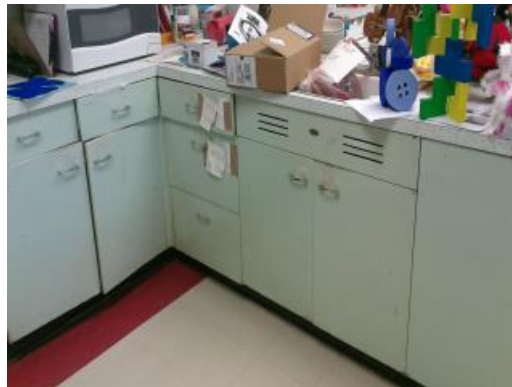
Typical Aged Cabinetry

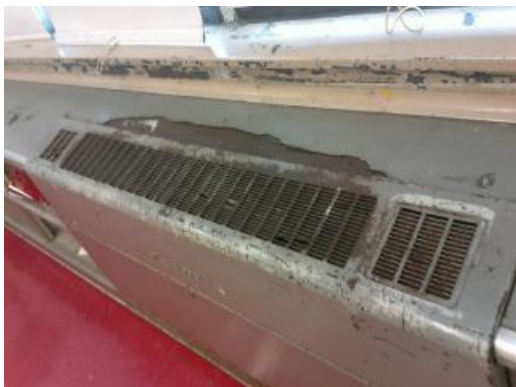
Aged Unit Vent

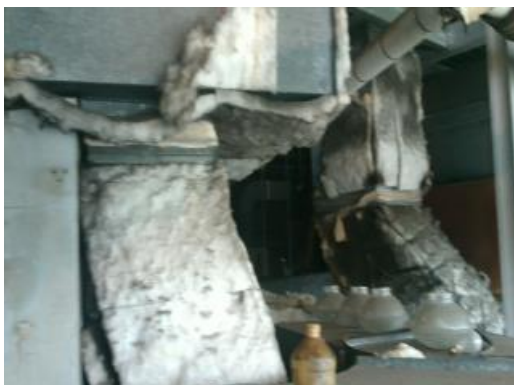
Failing AHU Insulation
